HISTORIC AMERICAN BUILDINGS SURVEY
INVENTORY

2. NAME *Orrin Thompson Mansion*

DATE OR PERIOD *1832*
STYLE *Greek Revival*
ARCHITECT
BUILDER *Orrin Thompson*

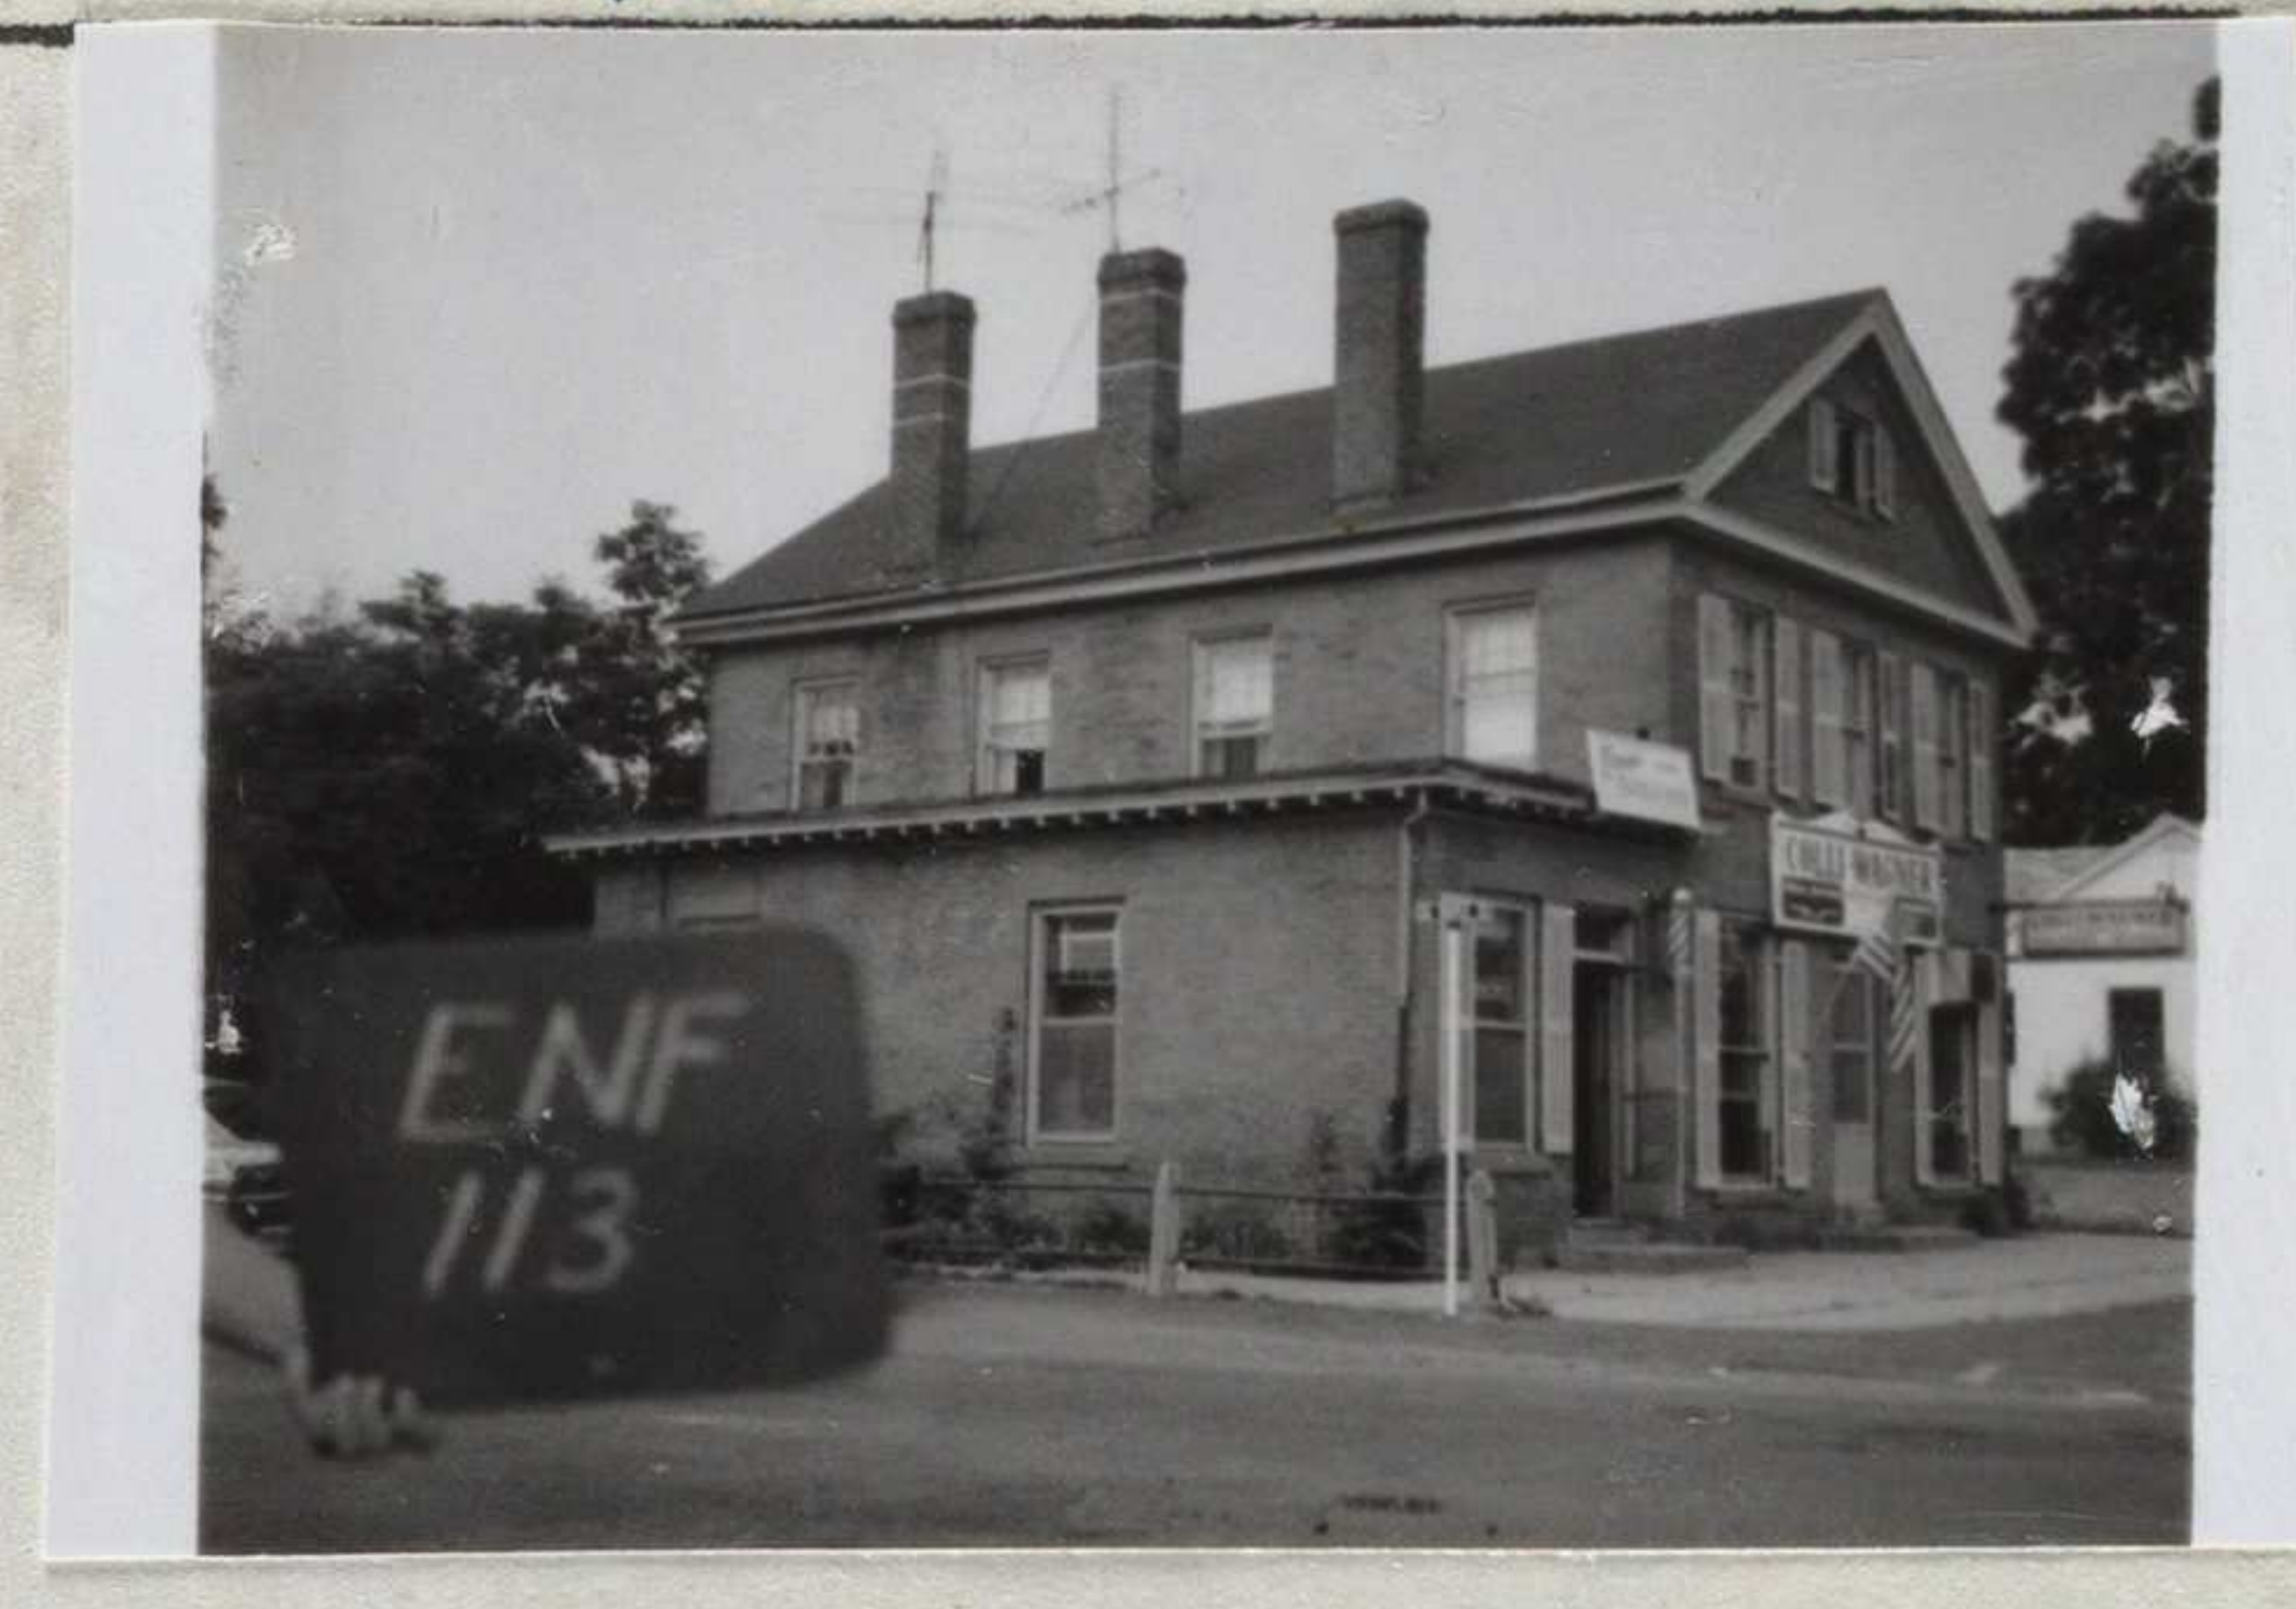
4. NOTABLE FEATURES, HISTORICAL SIGNIFICANCE AND DESCRIPTION	OPEN TO PUBLIC <i>No</i>
<p><i>The only brownstone on this building is to be found in the lintels and sills of the windows (6/6). There are three bays to the North (Main) side and 4 to the East, a side chimney between each pair on that side. The windows are shuttered, the roof shallow. The store front has been somewhat changed and additions have been made.</i></p>

5. PHYSICAL CONDITION OF STRUCTURE	Endangered <i>No</i>	Interior <i>Poor?</i>	Exterior <i>fair</i>
6. LOCATION MAP (Plan Optional)	7. PHOTOGRAPH <i>Enf 113</i>

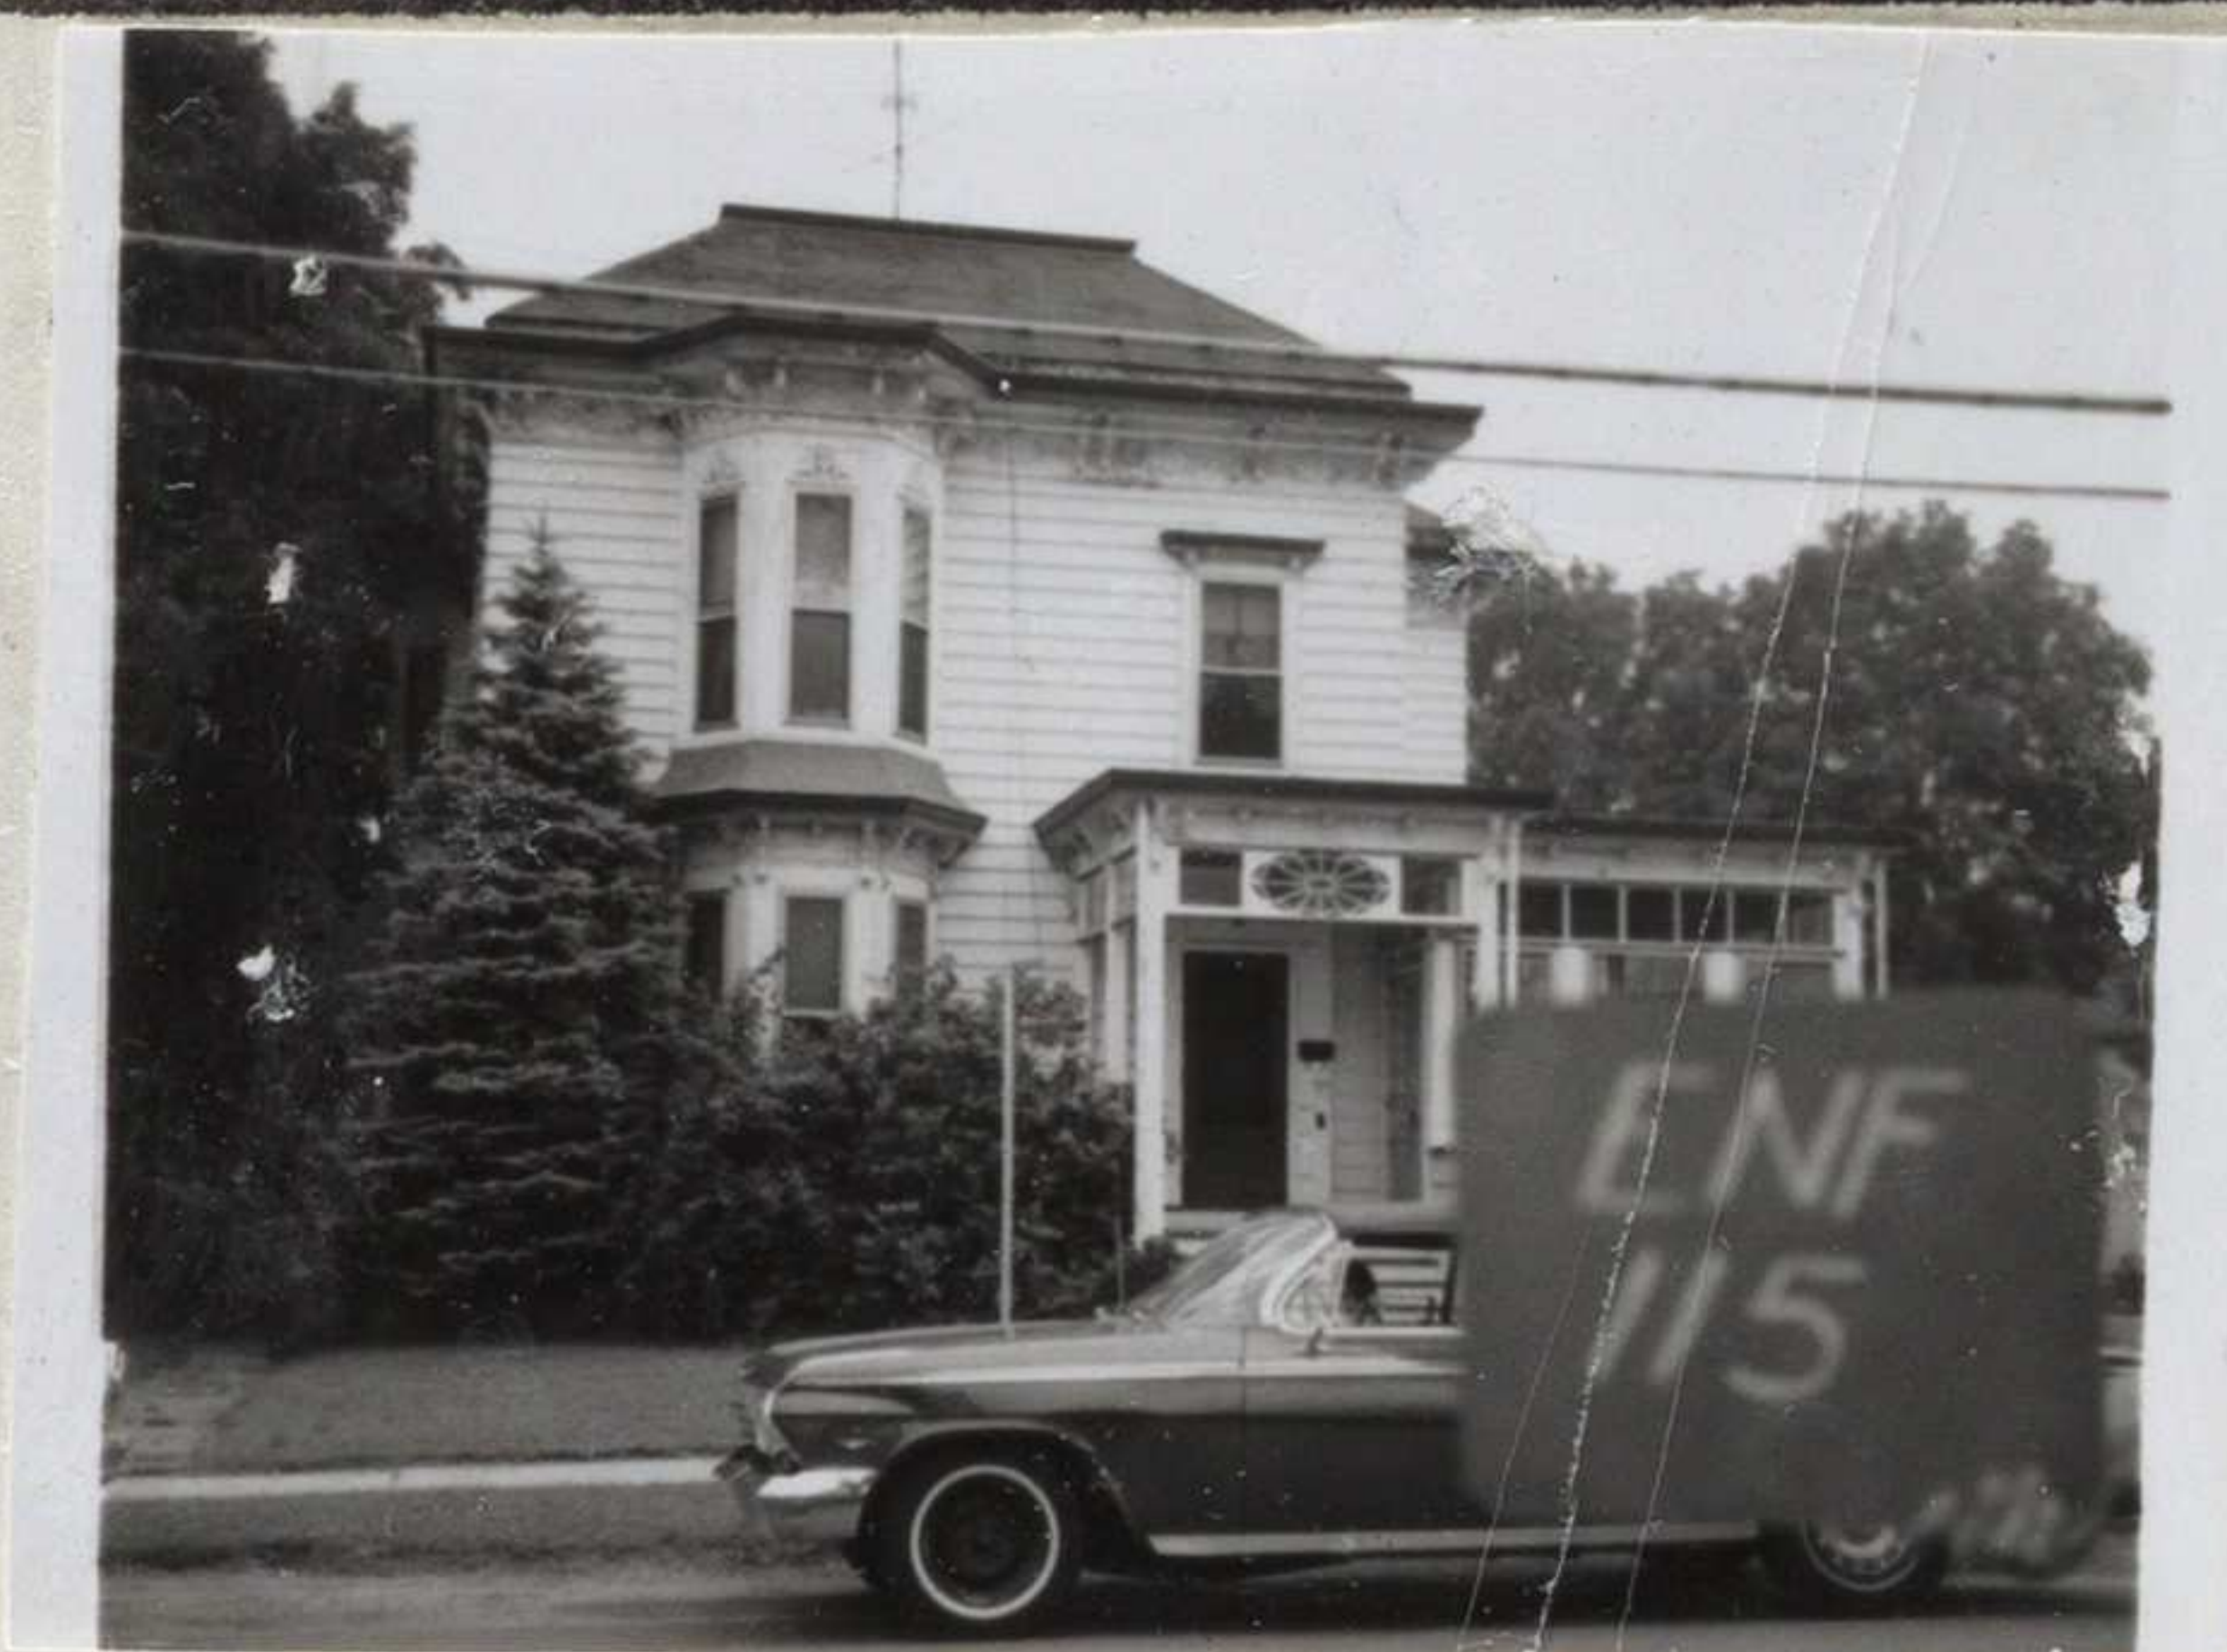
7. PHOTOGRAPH *Ent 115*

Built on a brick foundation, this 19th century house has but two facade bays, one the door bay, the other a bay window bay. Newer porches obliterate the doorway which has both ^{pannelled} sidelights and transom. To the East there is projection to the wall line, to the West another two story bay window. The finest features of the house are the scrollwork decorations, and brackets.

5. PHYSICAL CONDITION OF STRUCTURE

Endangered *No* Interior *fair?* Exterior *fair*

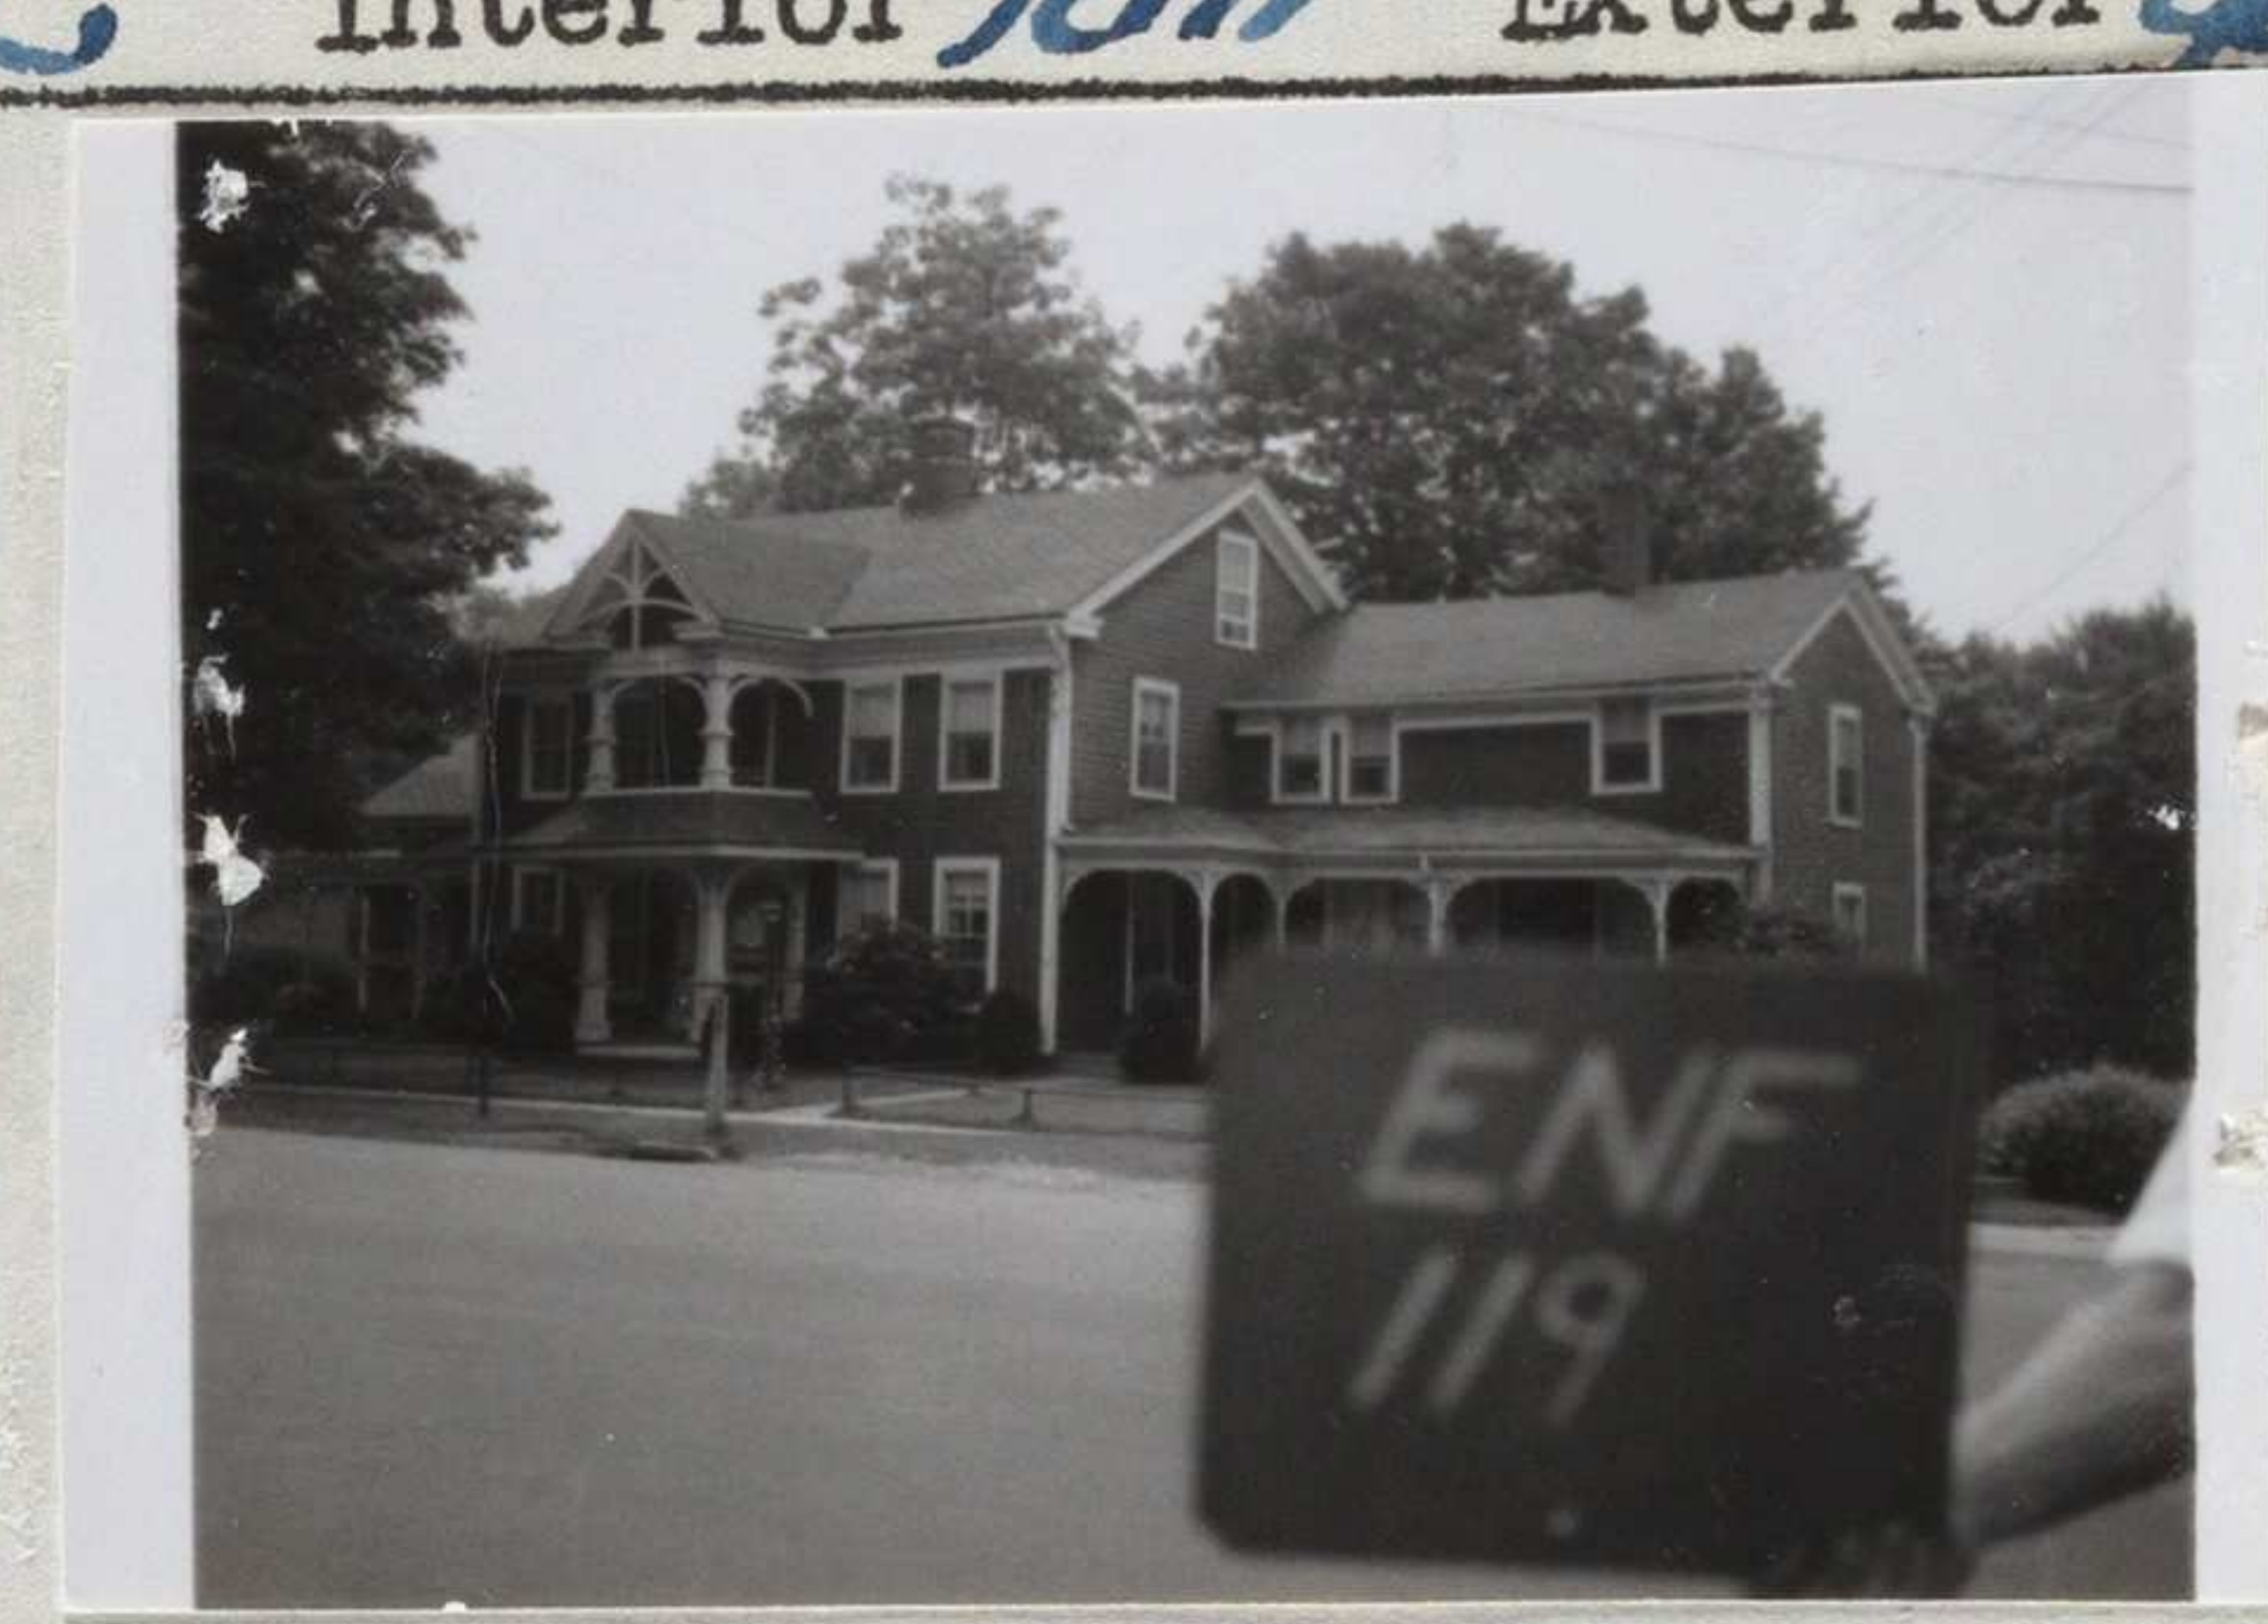
<div>1. STATE <i>Ct</i> COUNTY <i>Hartford</i> TOWN <i>Enfield</i> VICINITY STREET NO. <i>94-96 Main Street</i> ORIGINAL OWNER ? ORIGINAL USE <i>Residence</i> PRESENT OWNER ? PRESENT USE <i>Residence</i> WALL CONSTRUCTION <i>clapboard</i> NO. OF STORIES <i>2</i></div>		<div>HISTORIC AMERICAN BUILDINGS SURVEY INVENTORY</div> <div>2. NAME DATE OR PERIOD <i>1840</i> STYLE <i>Greek Revival</i> ARCHITECT BUILDER</div> <div>3. FOR LIBRARY OF CONGRESS USE</div>	
<div>4. NOTABLE FEATURES, HISTORICAL SIGNIFICANCE AND DESCRIPTION</div> <div><i>The basic features of this house are by now familiar: brownstone foundation, five bays, 6/6 windows, central chimney, shallow pitched roof. However the 1870's had there effect here and transformed the house entirely. A gable punctuates the facade atop a two story scrollwork porch. Other porches decorated wings to both E and W.</i></div>		<div>OPEN TO PUBLIC <i>No</i></div>

</div>		<div>Endangered <i>No</i> Interior <i>fair</i> Exterior <i>good</i></div> <div>

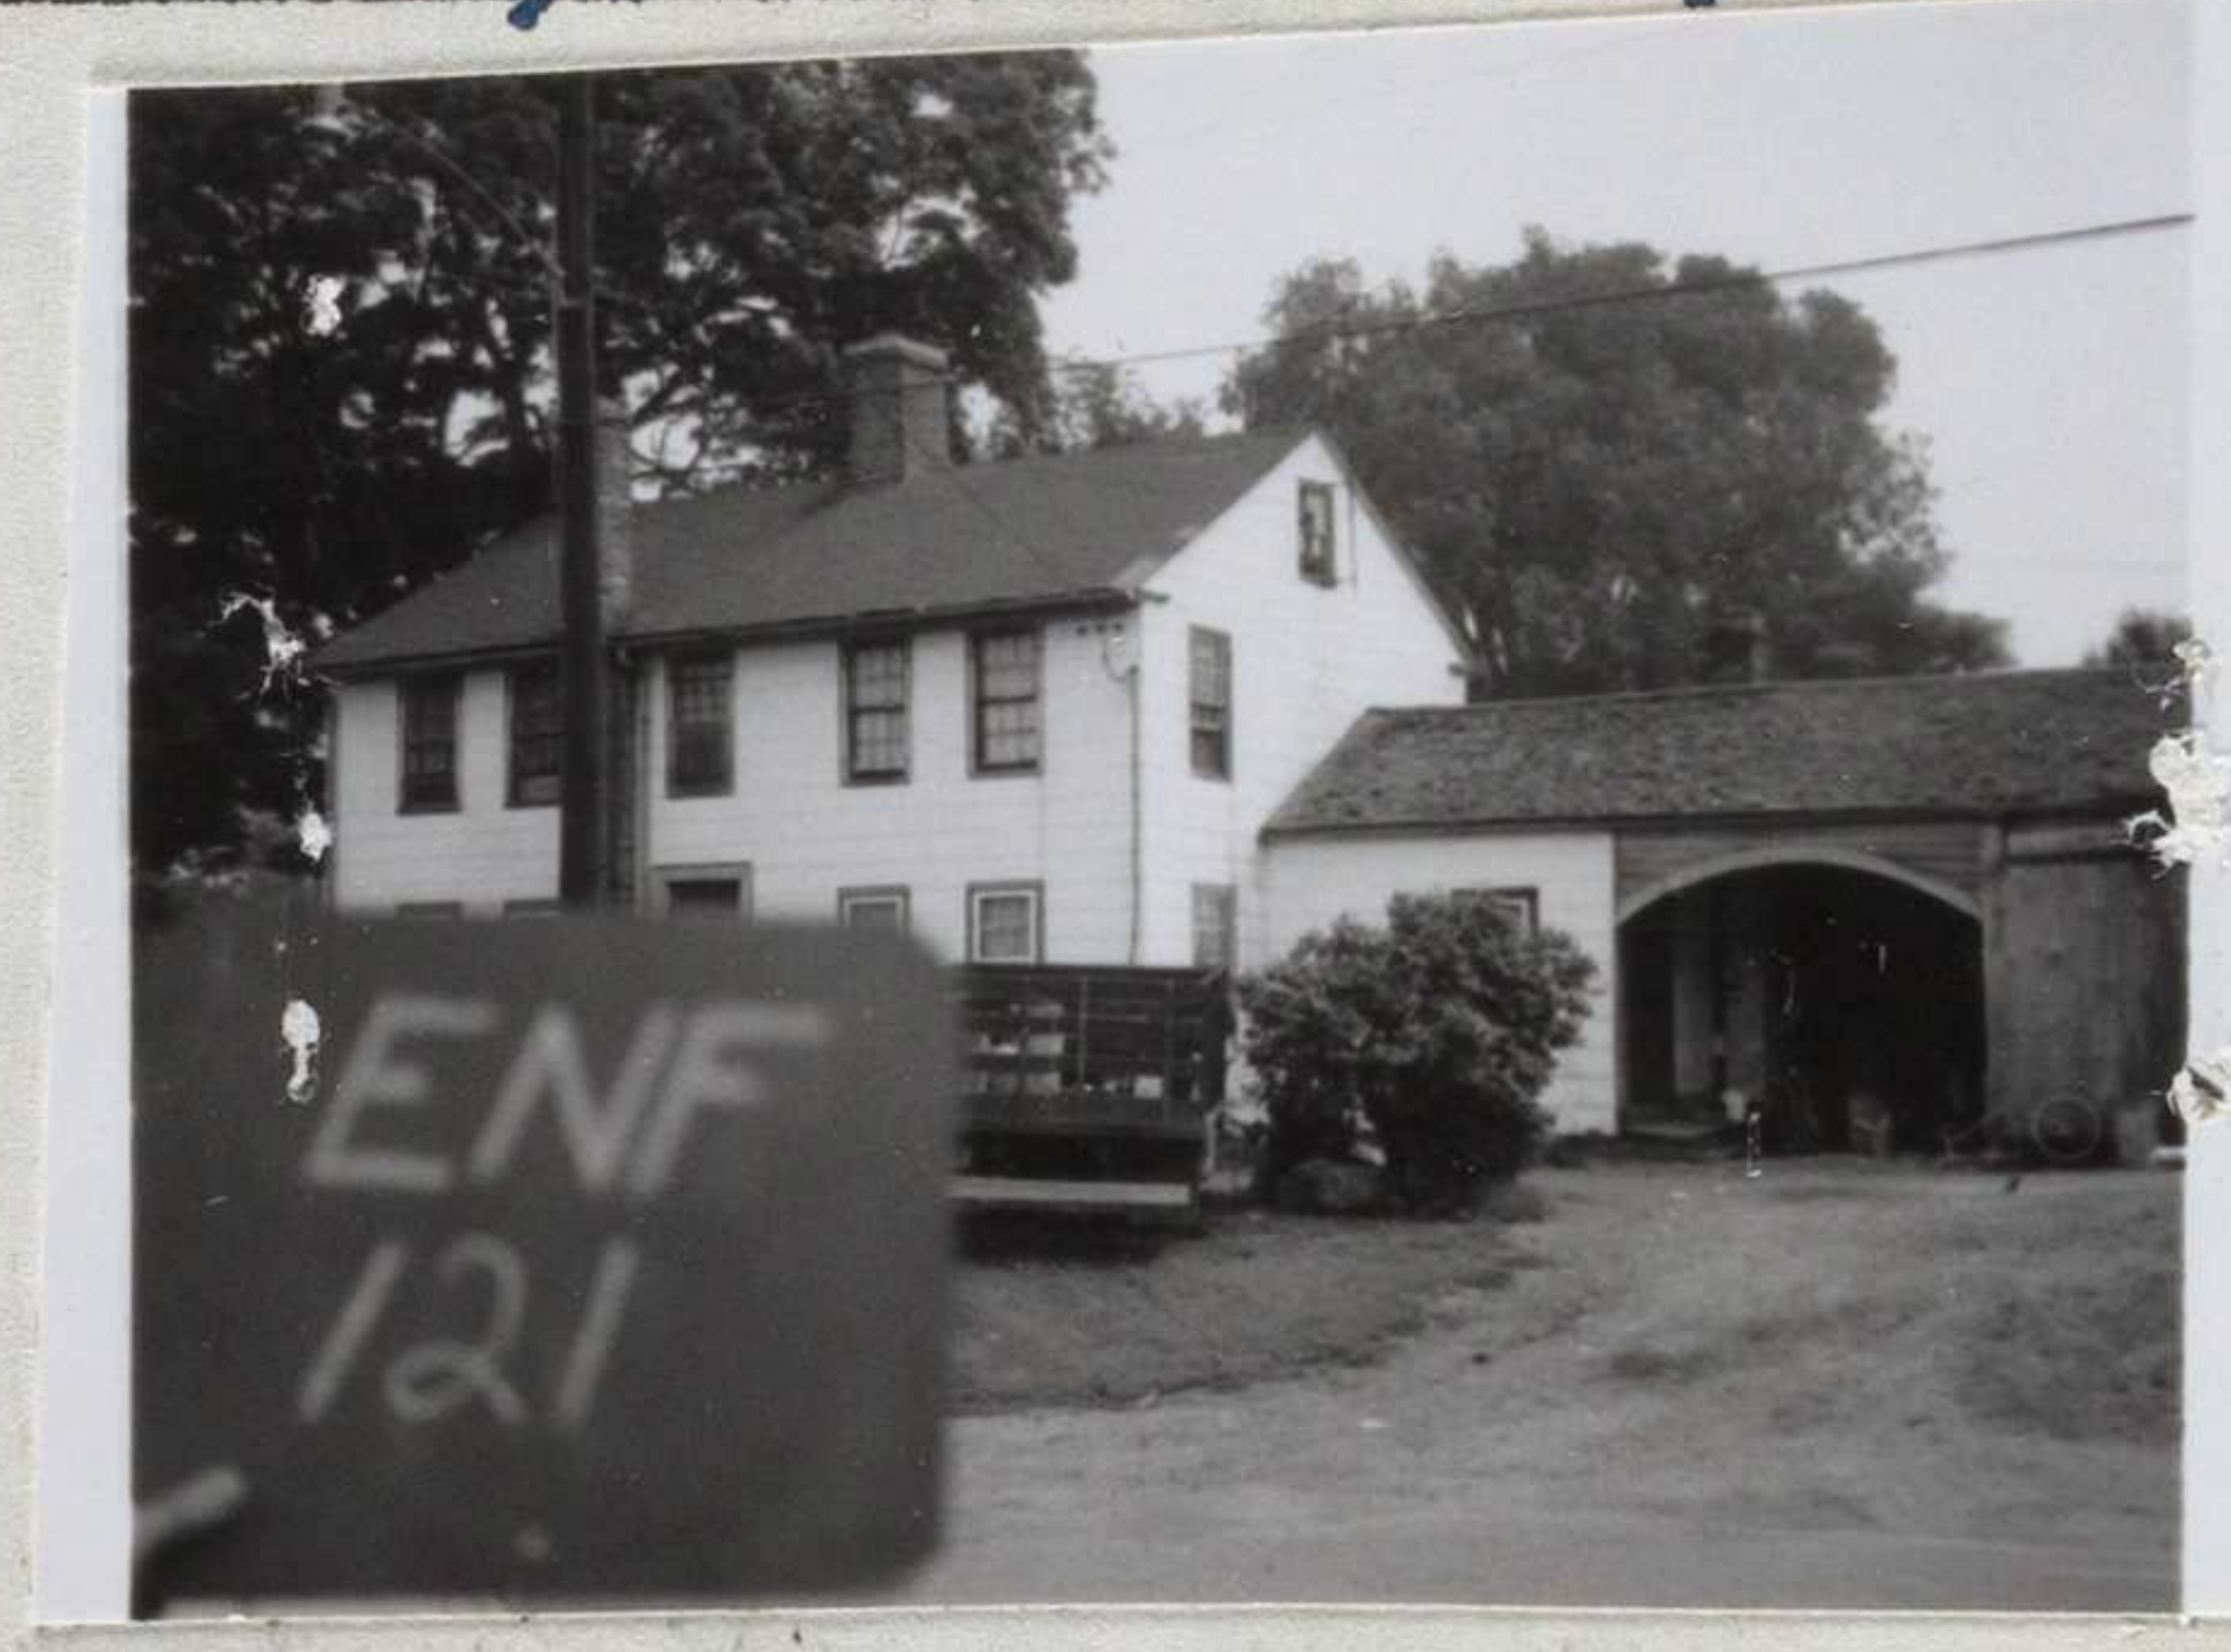
</div>		<div>7. PHOTOGRAPH <u>Enf 121</u></div> <div>

<div>1. STATE <u>Ct</u> COUNTY <u>Hartford</u> TOWN <u>Enfield</u> VICINITY STREET NO. <u>S.E. corner of Main and</u> <u>Water Streets</u> ORIGINAL OWNER ? ORIGINAL USE <u>Residence</u> PRESENT OWNER ? PRESENT USE <u>Residence</u> WALL CONSTRUCTION <u>John-Mansville</u> NO.OF STORIES <u>2</u></div>		<div>HISTORIC AMERICAN BUILDINGS SURVEY INVENTORY</div> <div>2. NAME DATE OR PERIOD <u>pre 1800?</u> STYLE <u>Federal</u> ARCHITECT Unknown BUILDER</div> <div>3. FOR LIBRARY OF CONGRESS USE</div>	
<div>4. NOTABLE FEATURES, HISTORICAL SIGNIFICANCE AND DESCRIPTION</div> <div><p><i>This fine old house is in sad condition. Built in five bays it is atop a brownstone foundation and capped with a shallow pitched roof. The windows are 4/6, but the attic windows are 8/8 which might suggest 14/12's originally on the main floors. The doorway has fine moldings and the original leaded transom. To the south is long shingle roofed ell including the segmental topped doorway of the former carriage house. Another wing extends to the rear. Unfortunately, however, there are multiple bastardizations to mar the original beauty of the place.</i></p></div> <div>OPEN TO PUBLIC <u>No</u></div>

<div>5. PHYSICAL CONDITION OF STRUCTURE</div> <div>Endangered <u>No</u> Interior <u>poor</u> Exterior <u>poor</u></div>			
<div>6. LOCATION MAP (Plan Optional)</div> <div>

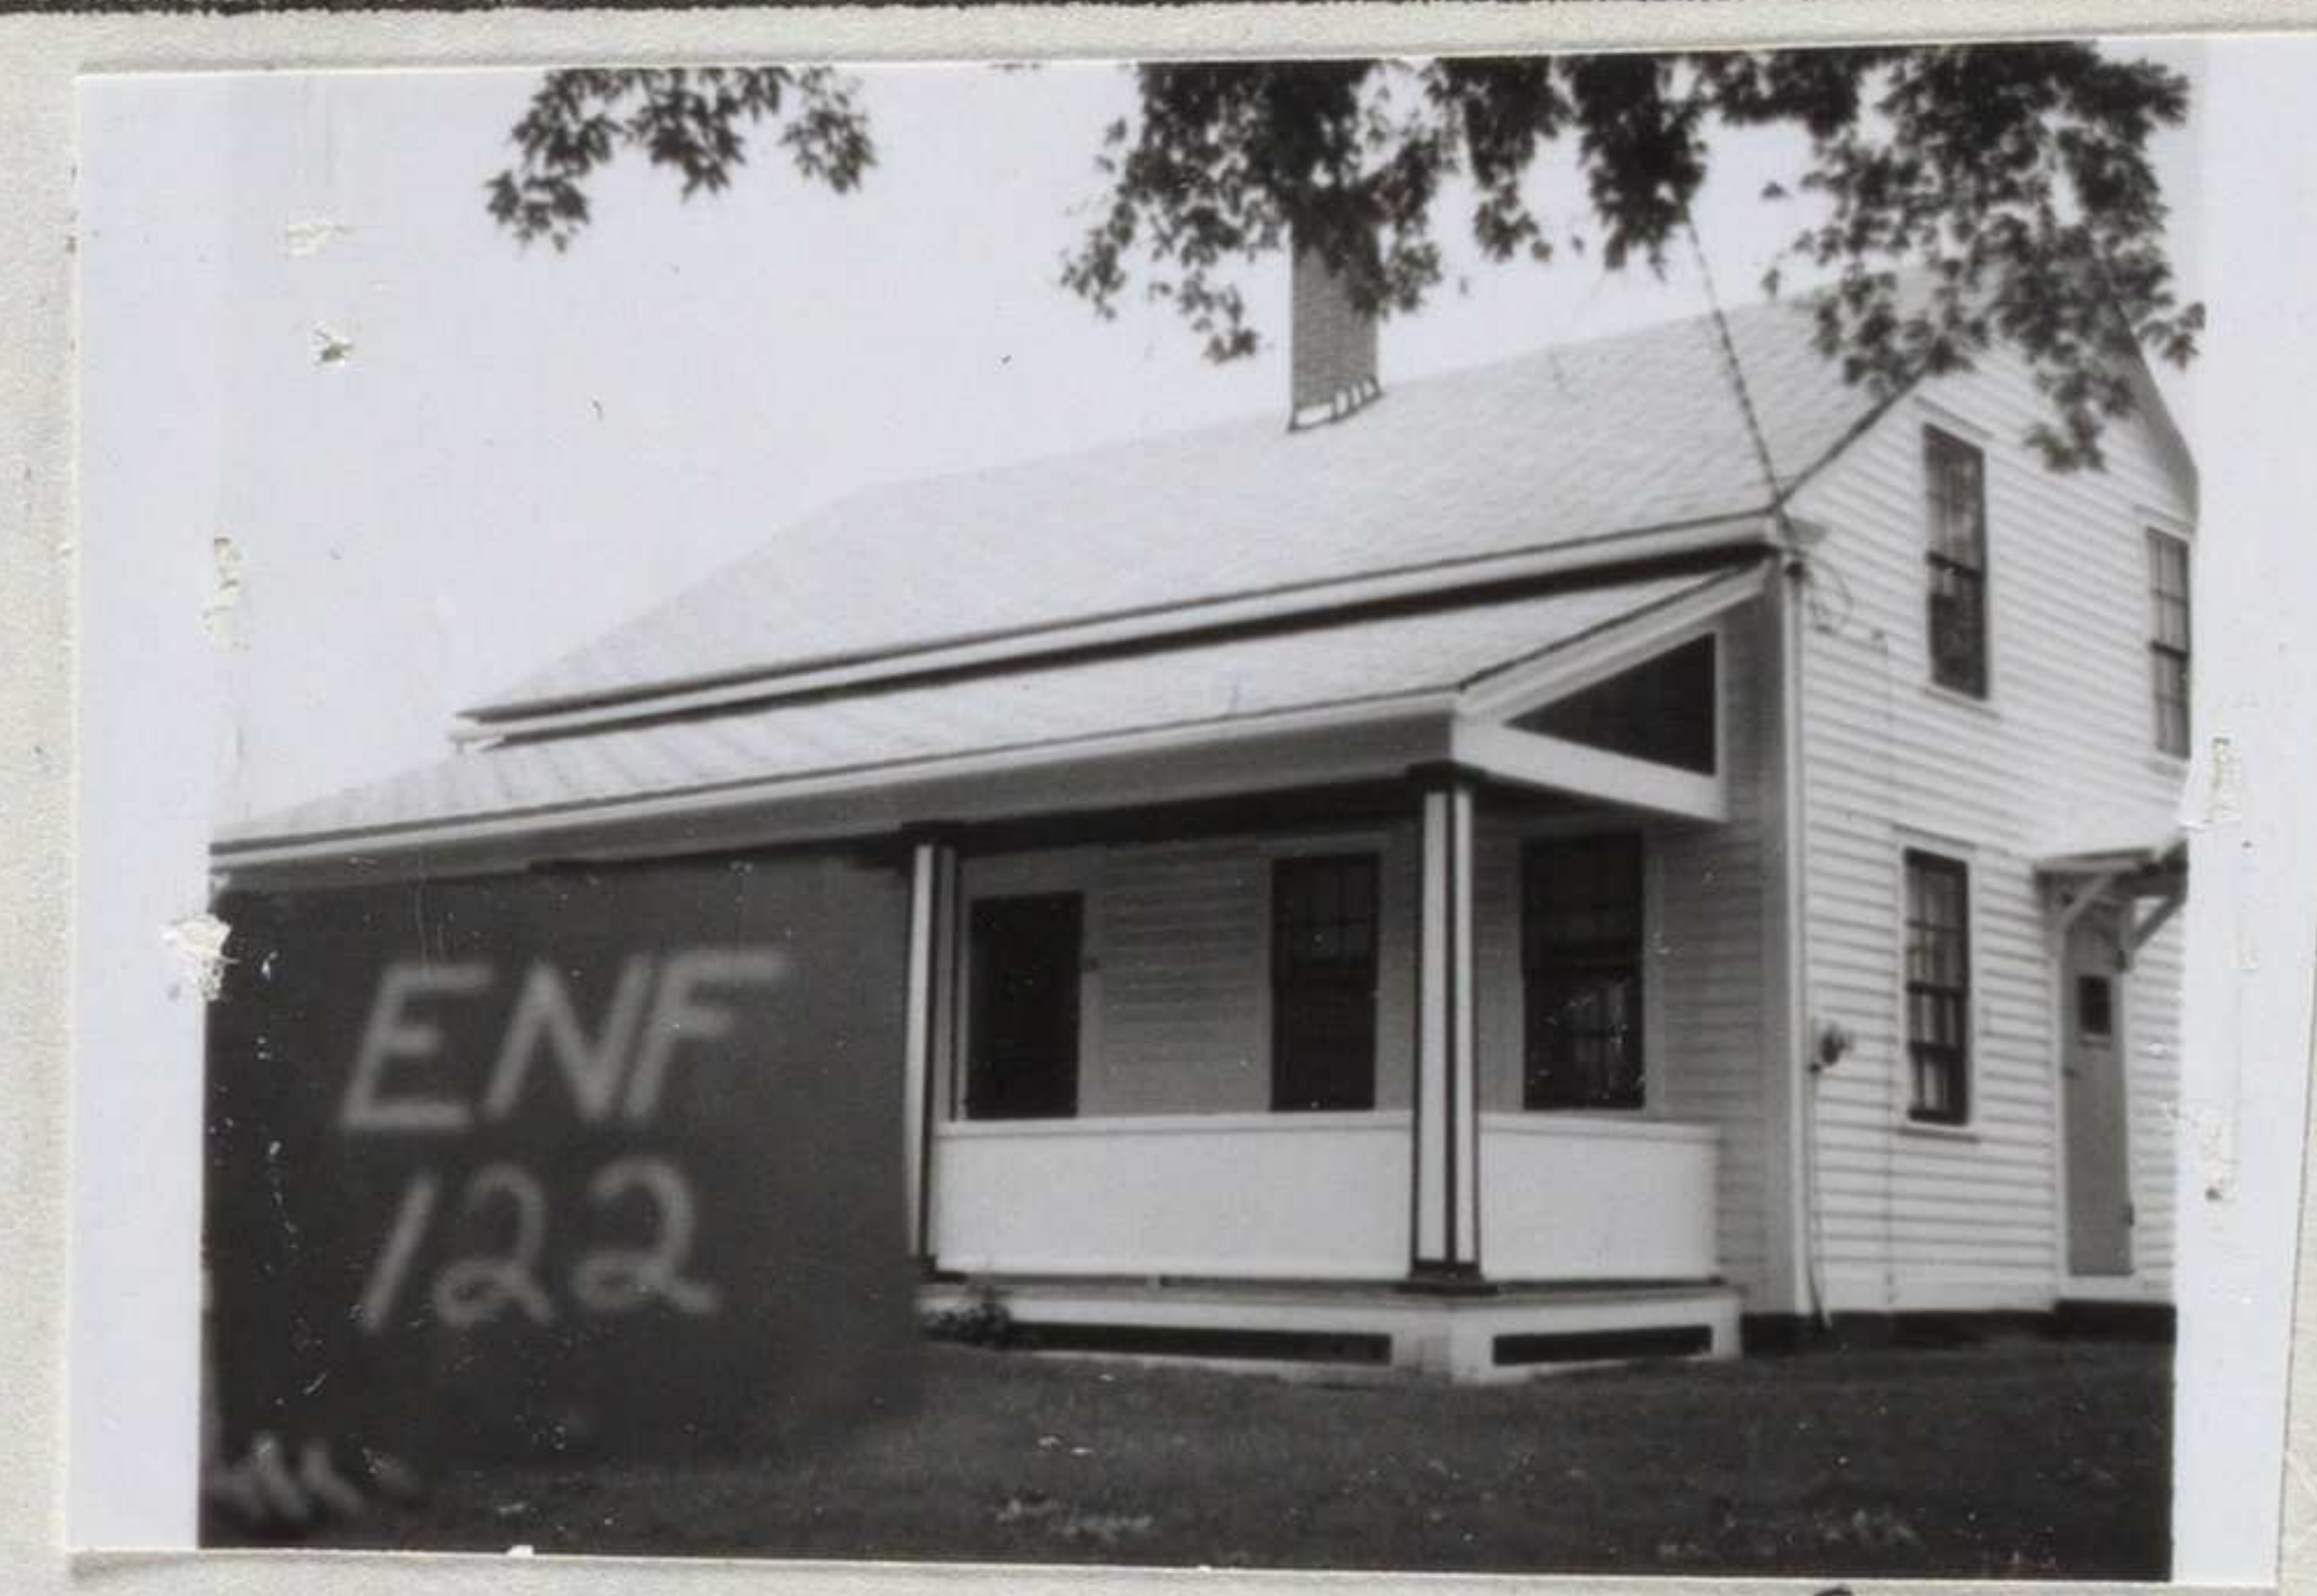
<p>7. PHOTOGRAPH <i>Enf 122</i></p>

<p>1. STATE <i>CT</i> COUNTY <i>Hartford</i> TOWN <i>Enfield</i> VICINITY STREET NO. <i>125 Main Street</i> ORIGINAL OWNER ? ORIGINAL USE <i>Residence</i> PRESENT OWNER ? PRESENT USE <i>Residence</i> WALL CONSTRUCTION <i>Cloppboard</i> NO.OF STORIES <i>1</i></p>		<p>HISTORIC AMERICAN BUILDINGS SURVEY INVENTORY</p> <p>2. NAME DATE OR PERIOD <i>1880?</i> STYLE <i>Colonial</i> ARCHITECT BUILDER</p> <p>3. FOR LIBRARY OF CONGRESS USE</p>	
<p>4. NOTABLE FEATURES, HISTORICAL SIGNIFICANCE AND DESCRIPTION</p> <p><i>This single story house is built on a brownstone foundation. It is in five bays. The medium pitched roof has a central chimney. The 6/8 windows have simple moldings. An added porch obliterates the doorway.</i></p>		<p>OPEN TO PUBLIC <i>No</i></p>	
<p>5. PHYSICAL CONDITION OF STRUCTURE</p> <p><i>Main Street</i></p>

<p><i>Pine Drive</i></p>		<p>Endangered ? Interior <i>fair?</i> Exterior <i>fair</i></p>
